**Flood Control Project Maintenance
Levee Inspections**

Fall 2018 Levee Maintenance Deficiency Summary Report

Sacramento River Basin

**Flood Control Project Maintenance
Levee Inspections****LMA District Cover Sheet****Fall 2018 Levee Inspection Results****Sutter Maintenance Yard Maintenance Area 0001**

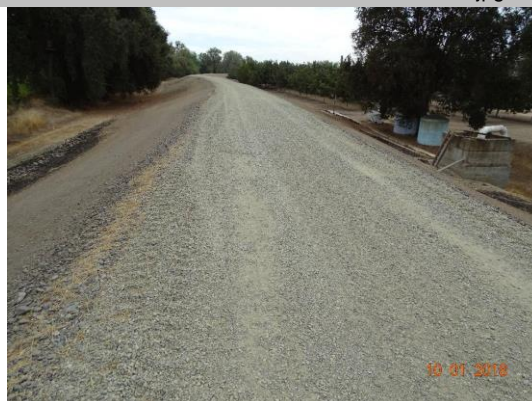
Photo 1 of 3 : UCIP_FA_2018_53059_78266.jpg

FS_ID:53059
DS_ID:16441
EP_NO: 9460
Repair Type: Urgent
Crossing Status: Found
UCIP Comments: 10/1/2018 A gap visible between pipe end in concrete box on LS and flap gate. Pipe might be partially silted that blocks flap gate from closing properly. Needs proper abandonment if not in use. Open conduit allows for flooding during high water events. (O.Yakimov - DWR)5/3/2017 Water leaked through this crossing during the Jan/Feb 2017 high water event. A concrete pipe of unknown diameter exits the LS distribution box and follows the levee alignment downstream about 120ft and uncontrolled water flowed from that pipe end. If crossing is abandoned then it needs to be done so properly. (DWR Sutter Yard- A Freitag)10/24/2016 This entire crossing now appears to be abandoned. The pvc pipe that was previously connected to the LS well pump is no longer connected and used to fill the box.(DWR Sutter Yard- A Freitag)4/25/2016 WS concrete box appears to be abandoned. LS box appears to get filled by a well pump on LS.4/21/2015 Same as last inspection.6/23/2014 Same as last inspection.12/17/2013 Same as last inspection.7/22/2013 Same as last inspection.10/30/2012 Need to determine if crossing is still being used there are some abandoned features that remain at this crossing-- crossing has been modified. This crossing was listed in the USACE Periodic Inspections as ID# USACE_CESPK_MA1C_2010_p_0464 for abandoned pump station.

View of levee crown at crossing.

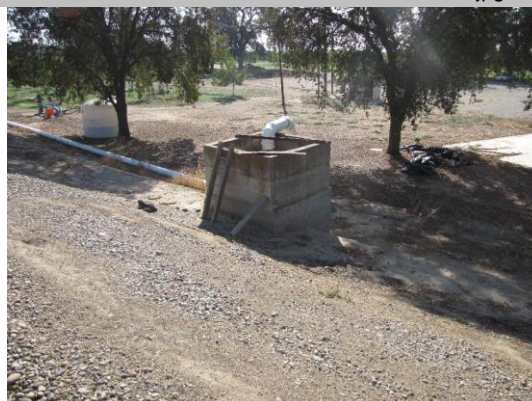
Photo 2 of 3 : UCIP_FA_2018_53059_70382.jpg

FS_ID:53059
DS_ID:16441
EP_NO: 9460
Repair Type: Urgent
Crossing Status: Found
UCIP Comments: 10/1/2018 A gap visible between pipe end in concrete box on LS and flap gate. Pipe might be partially silted that blocks flap gate from closing properly. Needs proper abandonment if not in use. Open conduit allows for flooding during high water events. (O.Yakimov - DWR)5/3/2017 Water leaked through this crossing during the Jan/Feb 2017 high water event. A concrete pipe of unknown diameter exits the LS distribution box and follows the levee alignment downstream about 120ft and uncontrolled water flowed from that pipe end. If crossing is abandoned then it needs to be done so properly. (DWR Sutter Yard- A Freitag)10/24/2016 This entire crossing now appears to be abandoned. The pvc pipe that was previously connected to the LS well pump is no longer connected and used to fill the box.(DWR Sutter Yard- A Freitag)4/25/2016 WS concrete box appears to be abandoned. LS box appears to get filled by a well pump on LS.4/21/2015 Same as last inspection.6/23/2014 Same as last inspection.12/17/2013 Same as last inspection.7/22/2013 Same as last inspection.10/30/2012 Need to determine if crossing is still being used there are some abandoned features that remain at this crossing-- crossing has been modified. This crossing was listed in the USACE Periodic Inspections as ID# USACE_CESPK_MA1C_2010_p_0464 for abandoned pump station.

Concrete distribution box located on LS toe.

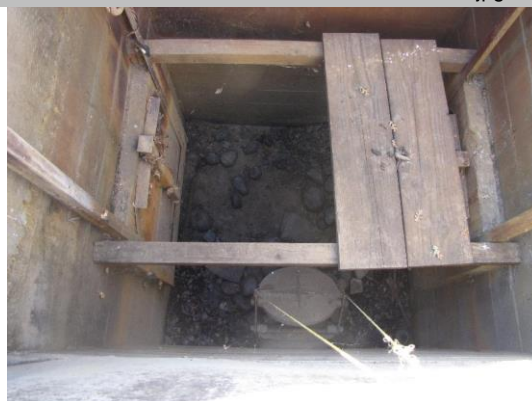
Photo 3 of 3 : UCIP_FA_2018_53059_70381.jpg

UCIP Comments: 10/1/2018 A gap visible between pipe end in concrete box on LS and flap gate. Pipe might be partially silted that blocks flap gate from closing properly. Needs proper abandonment if not in use. Open conduit allows for flooding during high water events. (O.Yakimov - DWR)5/3/2017 Water leaked through this crossing during the Jan/Feb 2017 high water event. A concrete pipe of unknown diameter exits the LS distribution box and follows the levee alignment downstream about 120ft and uncontrolled water flowed from that pipe end. If crossing is abandoned then it needs to be done so properly. (DWR Sutter Yard- A Freitag)10/24/2016 This entire crossing now appears to be abandoned. The pvc pipe that was previously connected to the LS well pump is no longer connected and used to fill the box.(DWR Sutter Yard- A Freitag)4/25/2016 WS concrete box appears to be abandoned. LS box appears to get filled by a well pump on LS.4/21/2015 Same as last inspection.6/23/2014 Same as last inspection.12/17/2013 Same as last inspection.7/22/2013 Same as last inspection.10/30/2012 Need to determine if crossing is still being used there are some abandoned features that remain at this crossing-- crossing has been modified. This crossing was listed in the USACE Periodic Inspections as ID# USACE_CESPK_MA1C_2010_p_0464 for abandoned pump station.

Inside view of concrete distribution box located on LS toe.

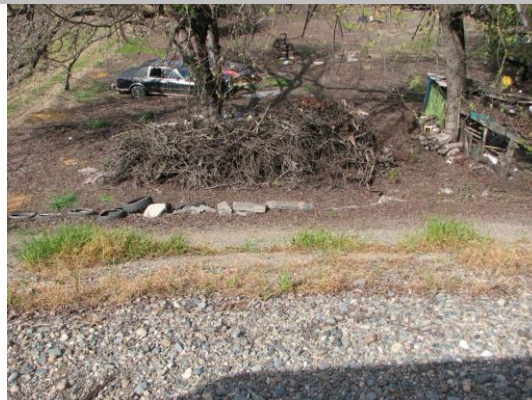
Photo 1 of 1 : FA_2018_MA0001_297_85_20180905_00020.jpg

LM Start	15.79	Rating **	U	Issue No.	85
LM End	15.79	Issue Type +	En	Location *	LS
Category	Earthen Levee			GPS Latitude/Longitude	
				Start	End
Item	Encroachments			39.399929 °	39.399929 °
				-122.010028 °	-122.010028 °
DWR ID	DWR_MA0001_01_s_2016_85				
Comment Code					
DE : Debris					
Inspector Comment					
prunings, concrete and tires.

View of prunings, concrete, and tires along the toe.

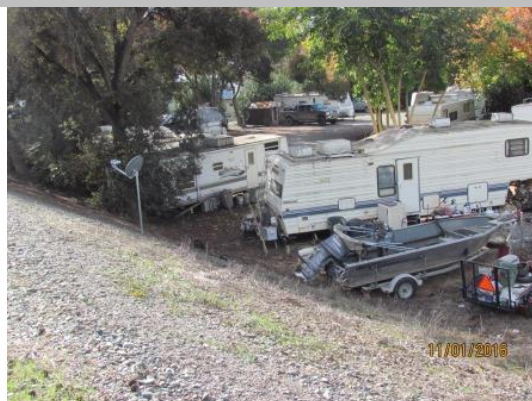
Photo 1 of 1 : FA_2018_MA0001_297_86_20180905_00021.jpg

LM Start	15.84	Rating **	U	Issue No.	86
LM End	15.90	Issue Type +	En	Location *	LS
Category	Earthen Levee			GPS Latitude/Longitude	
				Start	End
Item	Encroachments			39.400601 °	39.401365 °
				-122.009889 °	-122.009374 °
DWR ID	DWR_MA0001_01_s_2016_86				
Comment Code					
BU : Building					
Inspector Comment					
Mobile homes and trailers.

View of the mobile homes and trailers along the landside toe.

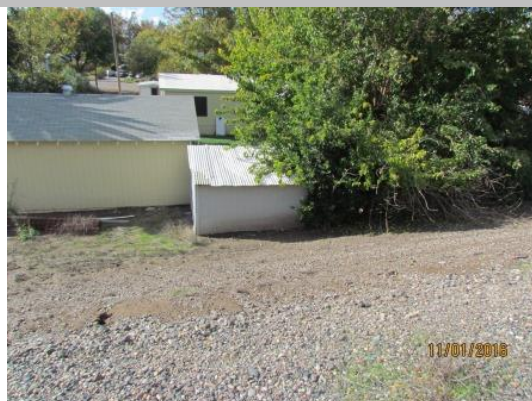
Photo 1 of 1 : FA_2018_MA0001_297_87_20180905_00022.jpg

LM Start	15.95	Rating **	U	Issue No.	87
LM End	15.95	Issue Type +	En	Location *	LS
Category	Earthen Levee			GPS Latitude/Longitude	
				Start	End
Item	Encroachments			39.401994 °	39.401994 °
				-122.009352 °	-122.009352 °
DWR ID	DWR_MA0001_01_s_2016_87				
Comment Code					
BU : Building					
Inspector Comment

View of a shed along the landside toe.

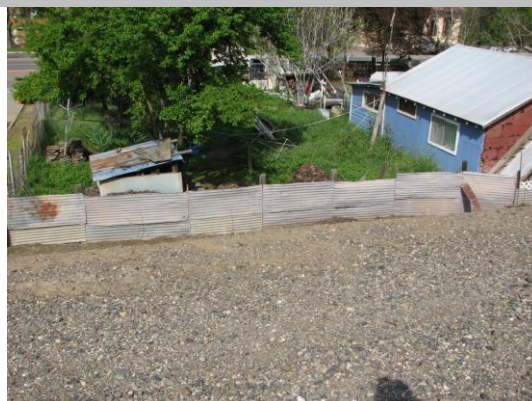
Photo 1 of 1 : FA_2018_MA0001_297_89_20180905_00023.jpg

LM Start	16.00	Rating **	U	Issue No.	89
LM End	16.02	Issue Type +	En	Location *	LS
Category	Earthen Levee			GPS Latitude/Longitude	
				Start	End
Item	Encroachments			39.402756 °	39.403040 °
				-122.009261 °	-122.009186 °
DWR ID	DWR_MA0001_01_s_2016_89				
Comment Code					
BU : Building					
Inspector Comment					
Red house and metal fence.

Corrugated metal fence obstructing visibility and access

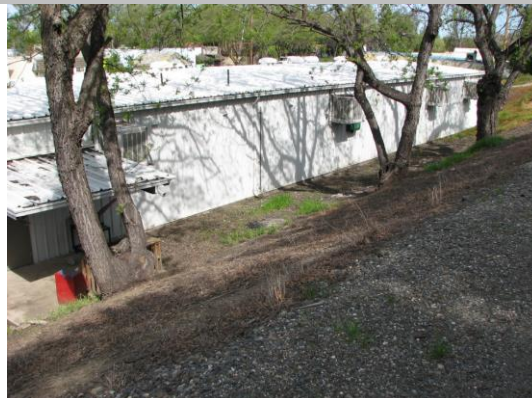
Photo 1 of 1 : FA_2018_MA0001_297_91_20180905_00025.jpg

LM Start	16.06	Rating **	U	Issue No.	91
LM End	16.06	Issue Type +	En	Location *	LS
Category	Earthen Levee			GPS Latitude/Longitude	
				Start	End
Item	Encroachments			39.403565 °	39.403565 °
				-122.009039 °	-122.009039 °
DWR ID	DWR_MA0001_01_s_2016_91				
Comment Code					
BU : Building					
Inspector Comment					
long, white metal building with several AC units

View of a building obstructing access.

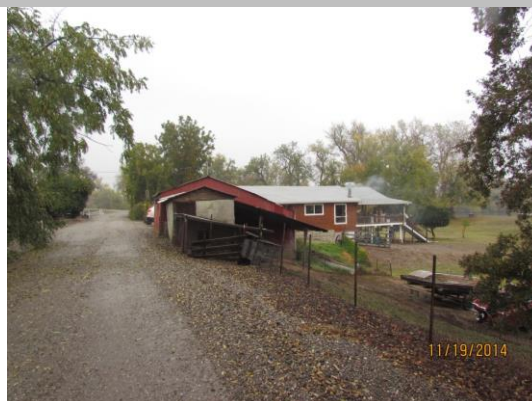
Photo 1 of 1 : FA_2018_MA0001_297_14_20180905_00008.jpg

LM Start	16.08	Rating **	U	Issue No.	14
LM End	16.08	Issue Type +	En	Location *	WS
Category	Earthen Levee			GPS Latitude/Longitude	
				Start	End
Item	Encroachments			39.403930 °	39.403930 °
				-122.008925 °	-122.008925 °
DWR ID	DWR_MA0001_01_s_2012_14				
Comment Code					
BU : Building					
Inspector Comment

View of the building on the waterside slope.

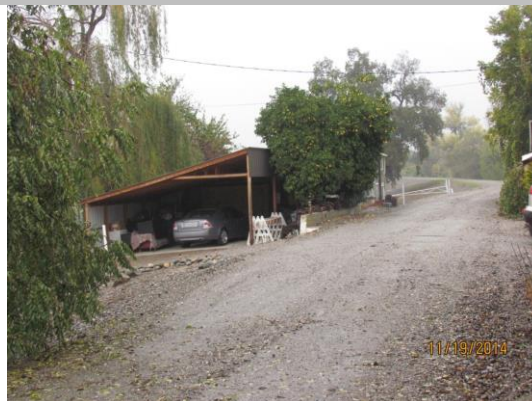
Photo 1 of 1 : FA_2018_MA0001_297_26_20180905_00012.jpg

LM Start	16.10	Rating **	U	Issue No.	26
LM End	16.10	Issue Type +	En	Location *	LS
Category	Earthen Levee			GPS Latitude/Longitude	
				Start	End
Item	Encroachments			39.404135 °	39.404135 °
				-122.008797 °	-122.008797 °
DWR ID	DWR_MA0001_01_s_2012_26				
Comment Code					
BU : Building					
Inspector Comment

View of the building on the landside slope.

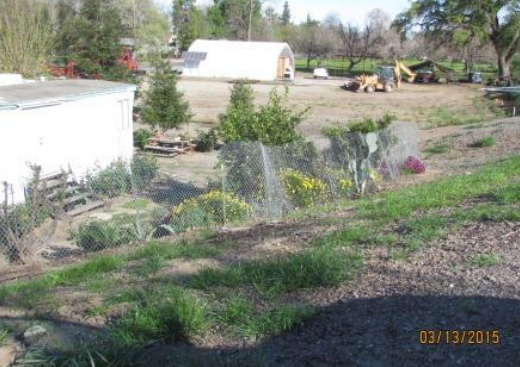
Photo 1 of 1 : FA_2018_MA0001_297_74_20180905_00017.jpg

View of the landscape along the landside slope and toe.

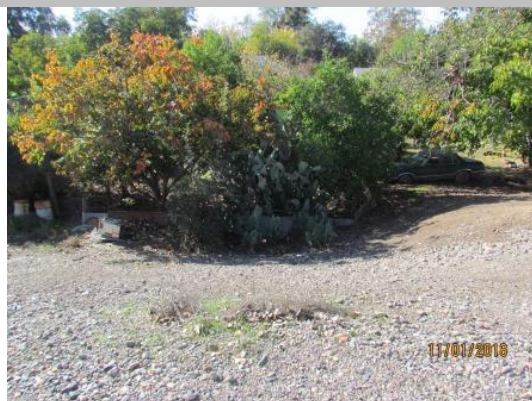
Photo 1 of 1 : FA_2018_MA0001_297_134_20180905_00040.jpg

LM Start	16.26	Rating **	M	Issue No.	134
LM End	16.26	Issue Type +	En	Location *	LS
Category	Earthen Levee			GPS Latitude/Longitude	
				Start	End
Item	Vegetation			39.406520 °	39.406520 °
				-122.008635 °	-122.008635 °
DWR ID	DWR_MA0001_01_f_2016_134				
Comment Code					
V6 : Landscaping					
Inspector Comment

View of cactus and fruit trees along the landside toe blocking visibility.

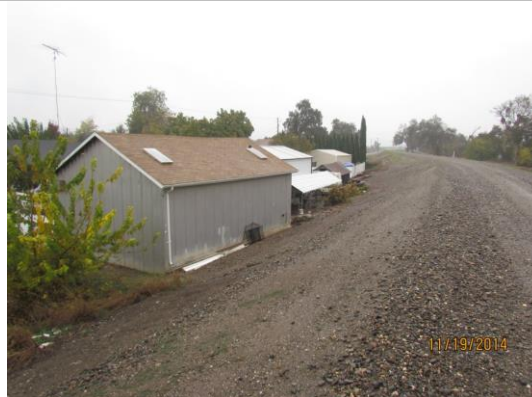
Photo 1 of 1 : FA_2018_MA0001_297_46_20180905_00014.jpg

LM Start	16.31	Rating **	U	Issue No.	46
LM End	16.33	Issue Type +	En	Location *	LS
Category	Earthen Levee			GPS Latitude/Longitude	
				Start	End
Item	Encroachments			39.407225 °	39.407545 °
				-122.008570 °	-122.008640 °
DWR ID	DWR_MA0001_01_s_2012_46				
Comment Code					
BU : Building					
Inspector Comment

View of the building along the landside toe.

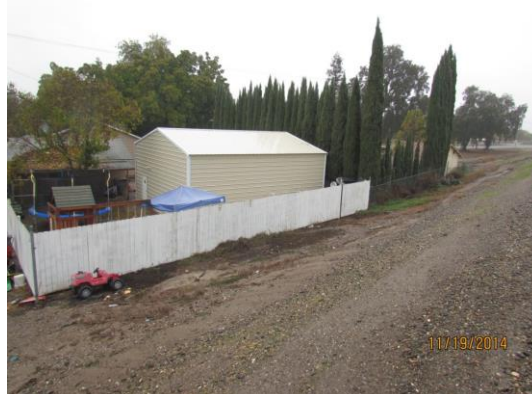
Photo 1 of 1 : FA_2018_MA0001_297_47_20180905_00015.jpg

LM Start	16.34	Rating **	U	Issue No.	47
LM End	16.35	Issue Type +	En	Location *	LS
Category	Earthen Levee			GPS Latitude/Longitude	
				Start	End
Item	Encroachments			39.407670 °	39.407823 °
				-122.008685 °	-122.008740 °
DWR ID	DWR_MA0001_01_s_2012_47				
Comment Code					
FE : Fence					
Inspector Comment

View of the fence along the landside toe.

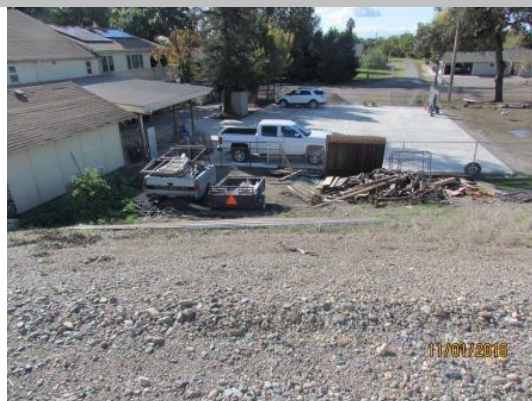
Photo 1 of 1 : FA_2018_MA0001_297_135_20180905_00041.jpg

LM Start	16.37	Rating **	M	Issue No.	135
LM End	16.37	Issue Type +	En	Location *	LS
Category	Earthen Levee			GPS Latitude/Longitude	
				Start	End
Item	Encroachments			39.408073 °	39.408073 °
				-122.009058 °	-122.009058 °
DWR ID	DWR_MA0001_01_f_2016_135				
Comment Code					
EQ : Equipment					
Inspector Comment					
Debris, metal, and firewood on the landside toe.

View of metal sheets along the levee slope and debris and firewood along the landside toe.

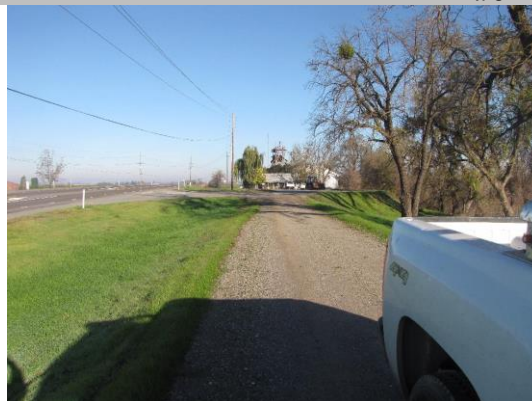
Photo 1 of 3 : UCIP_FA_2018_51916_70391.jpg

Comment Code						
Inspector Comment						
FS_ID:51916 DS_ID:16448 EP_NO: 14424 Repair Type: Non-Urgent Crossing Status: Found UCIP Comments: 5/3/2017 WS sign still knocked over- needs to be replaced. (DWR Sutter Yard- A Freitag)10/24/2016 WS marker sign still knocked over.(DWR Sutter Yard- A Freitag)4/25/2016 WS marker sign is still knocked over.4/21/2015 Same as last inspection.11/3/2014 (DWR-Olivia) Need to contact owner to determine when markers will be placed. 6/23/2014 Same as last inspection.12/17/2013 Same as last inspection7/22/2013 Same as last inspection.12/2012 Waiting for information regarding crossing from PG&E. Regarding damage warning sign--PG&E has initiated a project to replace pipeline crossing sign and utility markers, as required by DOT codes/regulations.11/2012 Utility warning sign damaged. Olivia (UCIP team) is coordinating with PG&E to determine more info on crossing. FIELD_STRUCT_DESC: 12-inch gas pipe through the levee, 30-inches below the crown. This 12-inch replacement pipe was installed by horizontally directionally drilling under the State HWY. Crossing is cathodically protected against external corrosion. Line was bored with a minimum cover of 48 feet under the right bank levee, 60 feet under the right bank, 25 feet under the channel and 52 feet under the left bank. Emergency contact: Monte Penland, Gas Maintenance Supervisor, 15871 Central Street, Meridian, CA 95957; Office No. 530-634-6520 or Mobile No. 530-356-7396. Utility crossing coordinates are approximate. This pipe is under pressure and cathodic protection (CP) readings are taken on a regular schedule. (Permit No. 14424, 1988 - Pacific Gas & Electric [PG&E]) [Additional Reference(s): DWR Levee Log, 1992]. FS Date: 5/23/2017 1:50:01 PM

View just upstream of utility crossing.

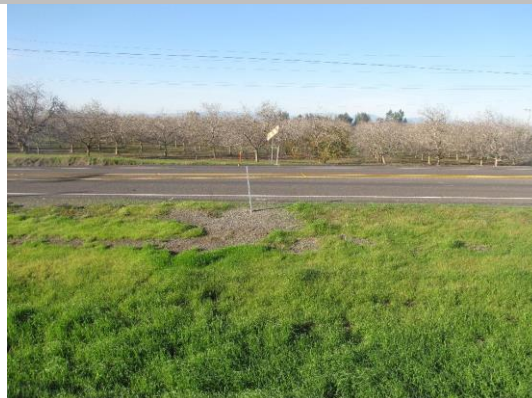
Photo 2 of 3 : UCIP_FA_2018_51916_70390.jpg

Item	DWR UCIP Field Study			39.410645 °	39.410645 °	
				-122.009705 °	-122.009705 °	
DWR ID	16448					
Comment Code						
Inspector Comment						
FS_ID:51916 DS_ID:16448 EP_NO: 14424 Repair Type: Non-Urgent Crossing Status: Found UCIP Comments: 5/3/2017 WS sign still knocked over- needs to be replaced. (DWR Sutter Yard- AFreitag)10/24/2016 WS marker sign still knocked over.(DWR Sutter Yard- AFreitag)4/25/2016 WS marker sign is still knocked over.4/21/2015 Same as last inspection.11/3/2014 (DWR-Olivia) Need to contact owner to determine when markers will be placed. 6/23/2014 Same as last inspection.12/17/2013 Same as last inspection7/22/2013 Same as last inspection.12/2012 Waiting for information regarding crossing from PG&E. Regarding damage warning sign--PG&E has initiated a project to replace pipeline crossing sign and utility markers, as required by DOT codes/regulations.11/2012 Utility warning sign damaged. Olivia (UCIP team) is coordinating with PG&E to determine more info on crossing. FIELD_STRUCT_DESC: 12-inch gas pipe through the levee, 30-inches below the crown. This 12-inch replacement pipe was installed by horizontally directionally drilling under the State HWY. Crossing is cathodically protected against external corrosion. Line was bored with a minimum cover of 48 feet under the right bank levee, 60 feet under the right bank, 25 feet under the channel and 52 feet under the left bank. Emergency contact: Monte Penland, Gas Maintenance Supervisor, 15871 Central Street, Meridian, CA 95957; Office No. 530-634-6520 or Mobile No. 530-356-7396. Utility crossing coordinates are approximate. This pipe is under pressure and cathodic protection (CP) readings are taken on a regular schedule. (Permit No. 14424, 1988 - Pacific Gas & Electric [PG&E]) [Additional Reference(s): DWR Levee Log, 1992]. FS Date: 5/23/2017 1:50:01 PM

View of utility marker located on LS across hwy.

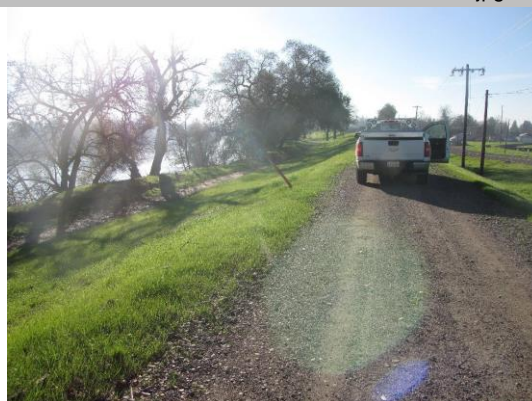
Photo 3 of 3 : UCIP_FA_2018_51916_70395.jpg

Item	DWR UCIP Field Study			39.410645 °		39.410645 °
				-122.009705 °		-122.009705 °
DWR ID	16448					
Comment Code						
Inspector Comment						
FS_ID:51916 DS_ID:16448 EP_NO: 14424 Repair Type: Non-Urgent Crossing Status: Found UCIP Comments: 5/3/2017 WS sign still knocked over- needs to be replaced. (DWR Sutter Yard- AFreitag)10/24/2016 WS marker sign still knocked over.(DWR Sutter Yard- AFreitag)4/25/2016 WS marker sign is still knocked over.4/21/2015 Same as last inspection.11/3/2014 (DWR-Olivia) Need to contact owner to determine when markers will be placed. 6/23/2014 Same as last inspection.12/17/2013 Same as last inspection7/22/2013 Same as last inspection.12/2012 Waiting for information regarding crossing from PG&E. Regarding damage warning sign--PG&E has initiated a project to replace pipeline crossing sign and utility markers, as required by DOT codes/regulations.11/2012 Utility warning sign damaged. Olivia (UCIP team) is coordinating with PG&E to determine more info on crossing. FIELD_STRUCT_DESC: 12-inch gas pipe through the levee, 30-inches below the crown. This 12-inch replacement pipe was installed by horizontally directionally drilling under the State HWY. Crossing is cathodically protected against external corrosion. Line was bored with a minimum cover of 48 feet under the right bank levee, 60 feet under the right bank, 25 feet under the channel and 52 feet under the left bank. Emergency contact: Monte Penland, Gas Maintenance Supervisor, 15871 Central Street, Meridian, CA 95957; Office No. 530-634-6520 or Mobile No. 530-356-7396. Utility crossing coordinates are approximate. This pipe is under pressure and cathodic protection (CP) readings are taken on a regular schedule. (Permit No. 14424, 1988 - Pacific Gas & Electric [PG&E]) [Additional Reference(s): DWR Levee Log, 1992]. FS Date: 5/23/2017 1:50:01 PM

View of levee looking downstream at crossing.
